2  
ade 000105  
NRL Memorandum Report 3666

## Biodeterioration of Membrane Separators for Use in an Oil Pollution Prevention System

M. E. MAY and R. A. NEIHOF

December 1977

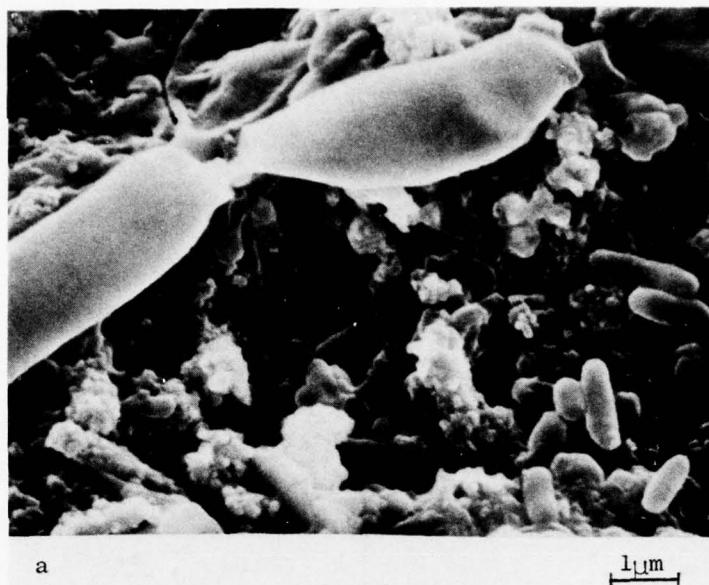
(a) Fungal material on the surface of a Hydrin membrane after one year exposure in JP-5 - sea water test unit inoculated with selected aerobic microorganisms

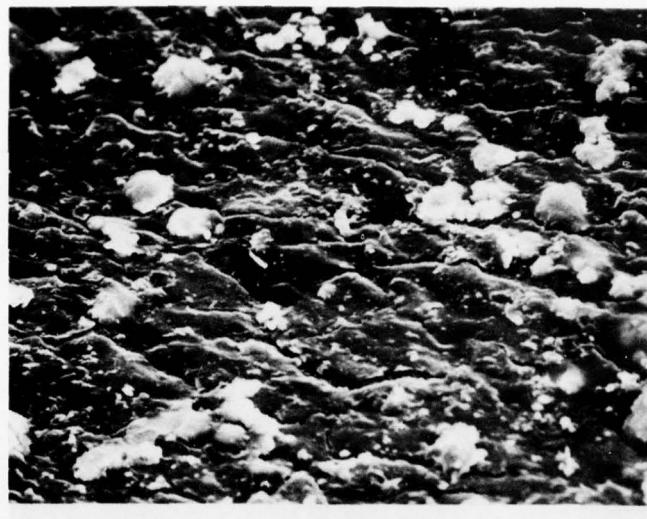
Figures 8a and 8b show the neoprene side of the neoprene/fabric/nitrile membrane before and after exposure for one year in the Two-Phase System. The original and exposed Hydrin surfaces are shown in Figures 9a and 9b. It should be noted that the Hydrin membrane shows more extensive surface cracks and flakes than the neoprene. An analysis of the surface deposits on the Hydrin rubber was made using x-ray energy dispersive spectrometry. The analysis indicated zinc, lead and iron were present in the flakes.

Fig. 9 — SEM photographs of a bent Hydrin membrane after detergent cleaning

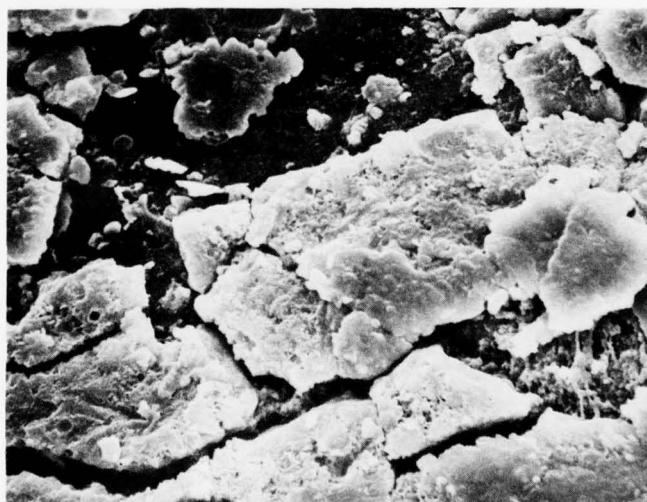
b

(b) After one year exposure in a N.D. - sea water test unit

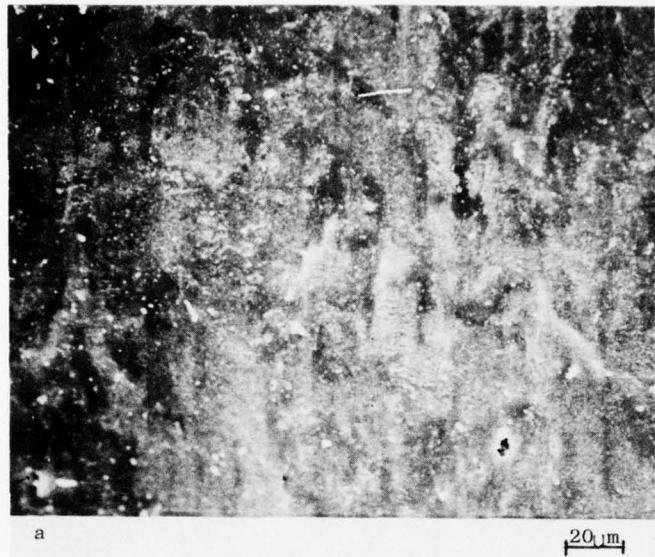
(a) Unexposed control treated with benzene followed by  
a dilute HCl solution
